# U-6A / NU-1B Technical Support Contract

## Aircraft Inspection Report

December 19, 2003

Document Number: 2003 NU-1B 0001

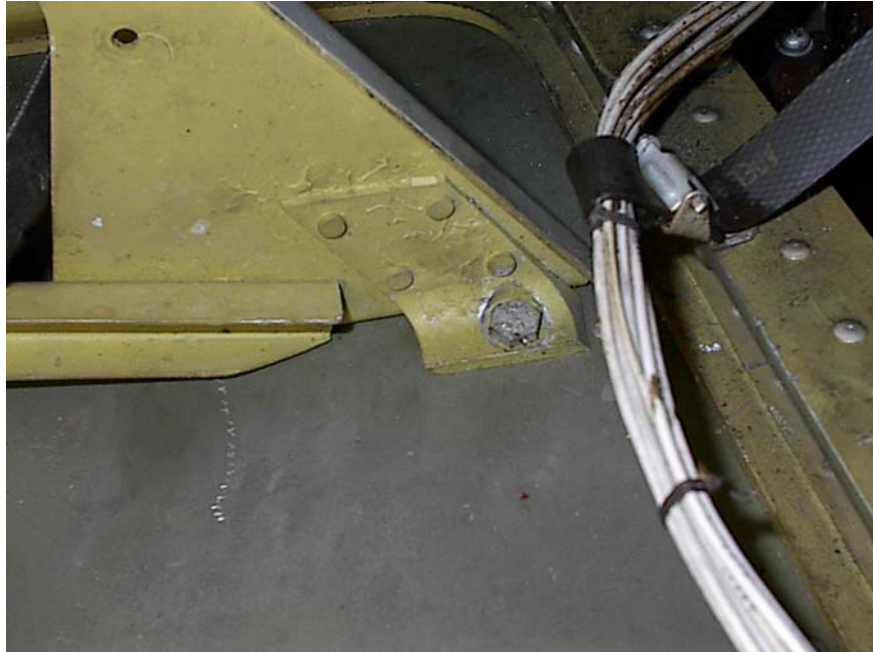
- 5.4.1.1. **Elevator/rudder quadrant assy mounted on STN 110 sloping bulkhead  
---2 1/4 bolts require lock wire.**

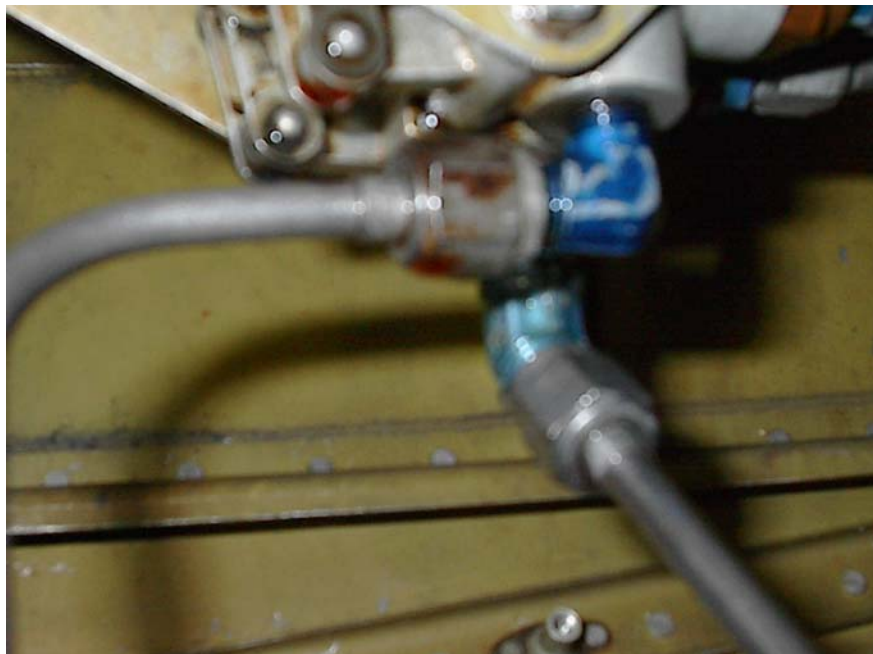
- 5.4.1.2. **Check parking brake valve for hydraulic leak (fluid residues on valve).**

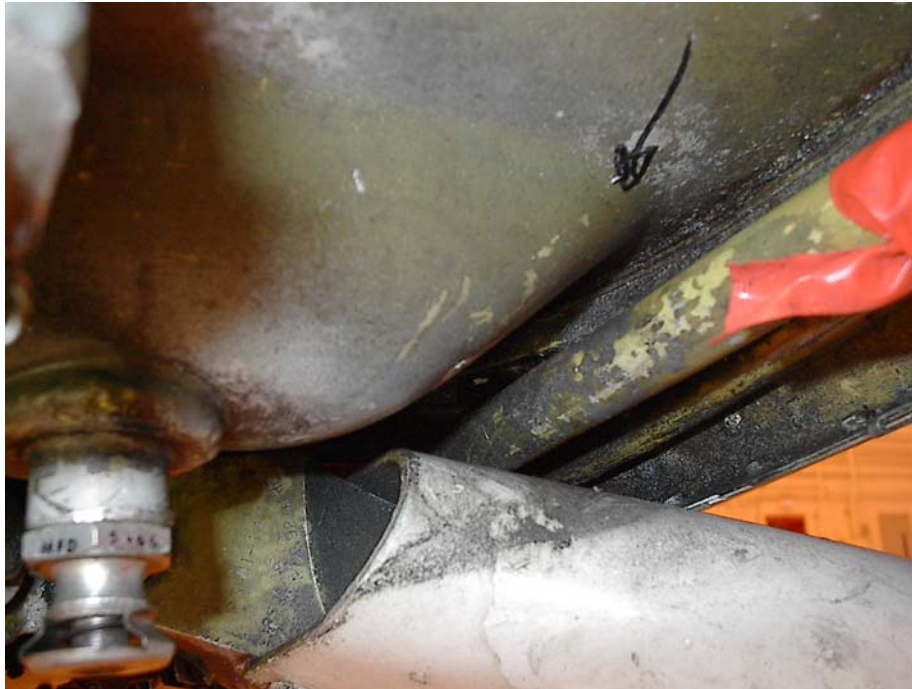
- 5.4.1.3. **Aft fuel feed tube is chafing on sump plate bolt head in area of MLG drag struts---requires inspection. Possible replacement if beyond 10% wall thickness.**

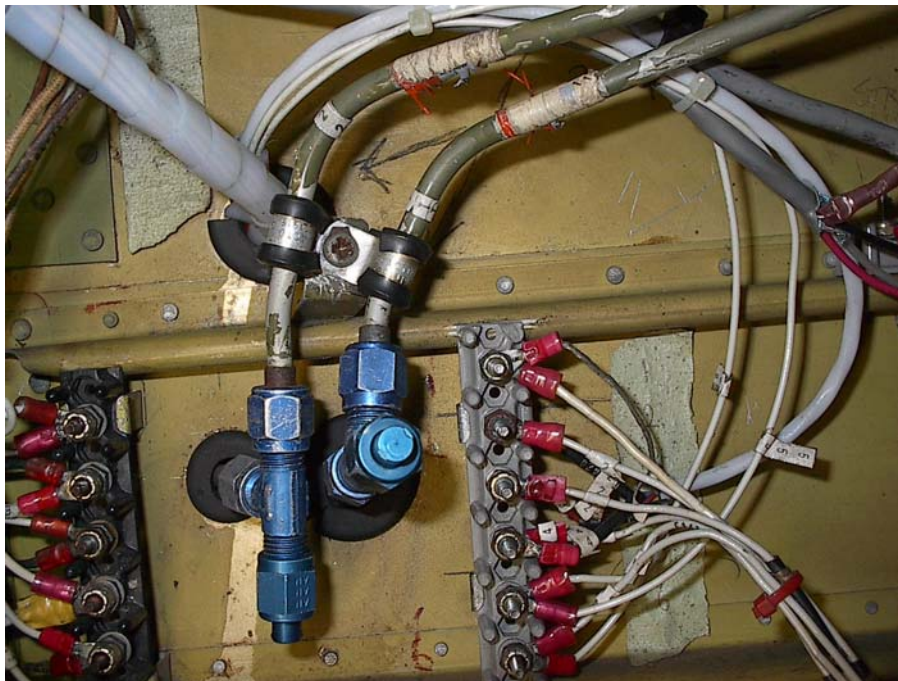
- 5.4.1.4. **Pilot/Static system missing drain pipes. Part # C2F 691A as per Illustrated Parts Catalogue, pg. 74**

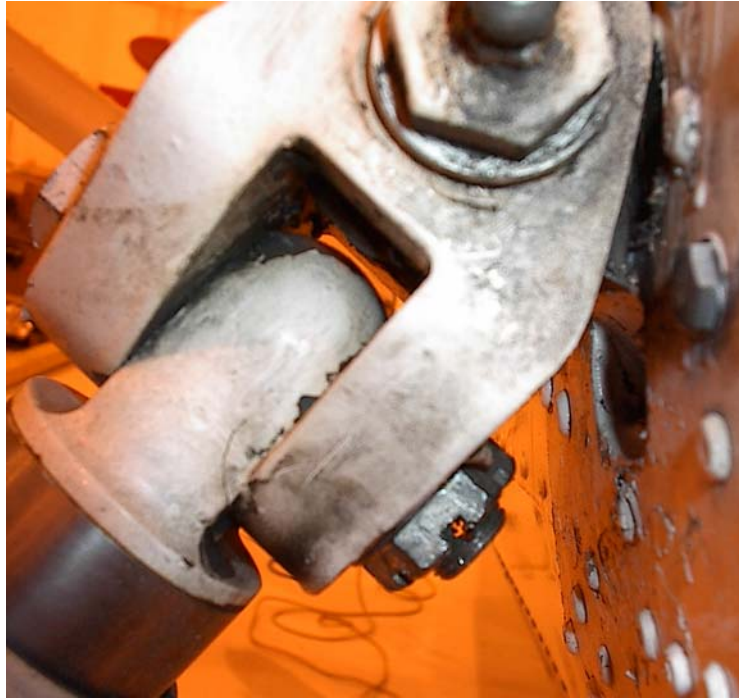
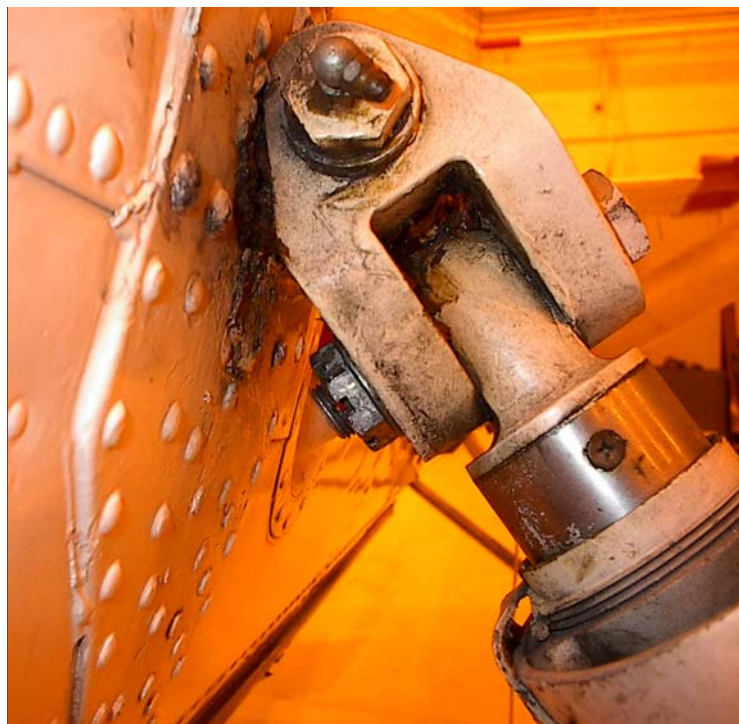
**5.4.1.5. No cotter pins on L/H and R/H shock strut to fuse attach points.**

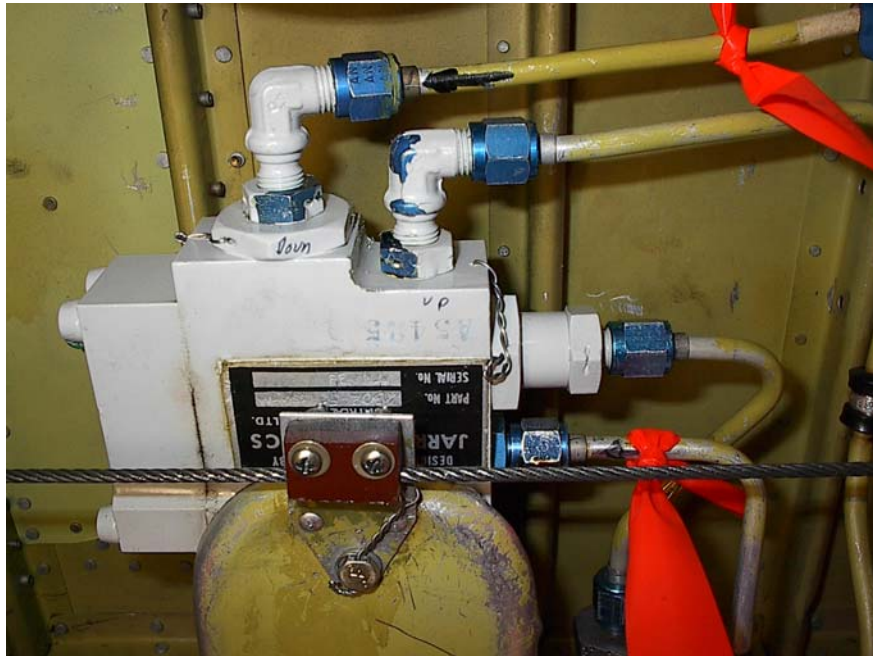
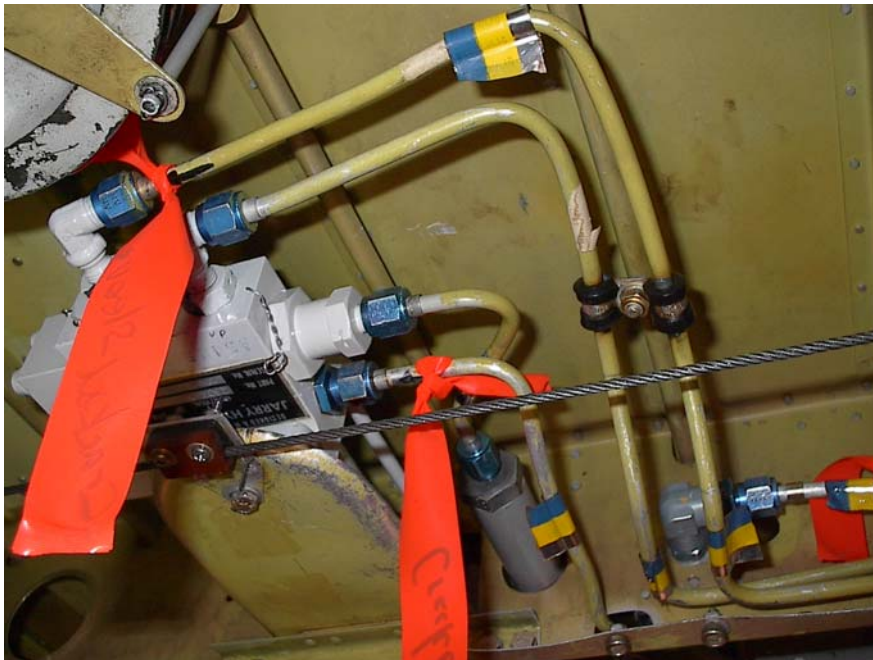
**5.4.1.6. 3 cracked sleeves on 3 separate hyd. lines leading to flap jack. 1 line currently leaks.**

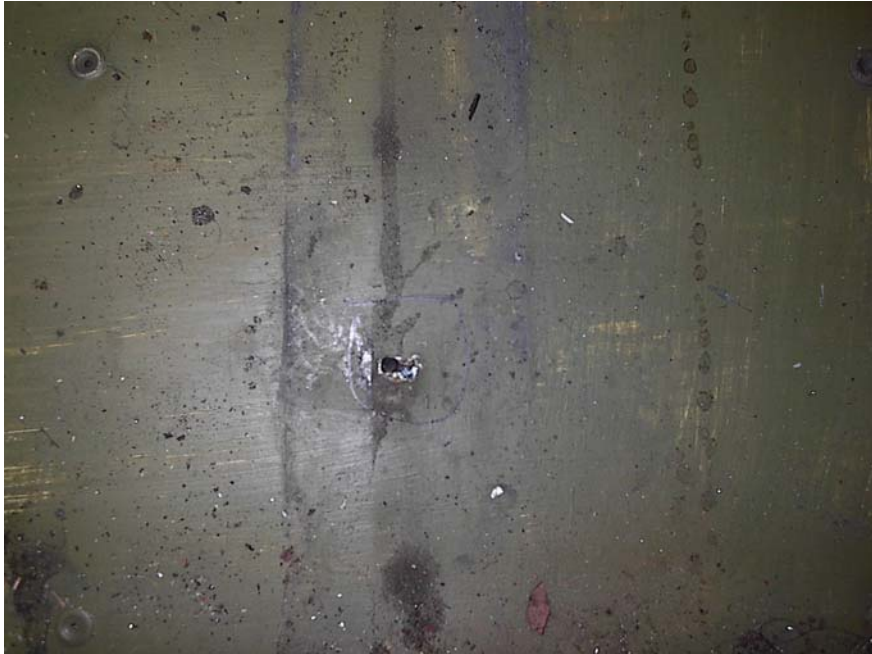
**5.4.1.7. Sheetmetal repair required on sub floor (rear tank cover)**

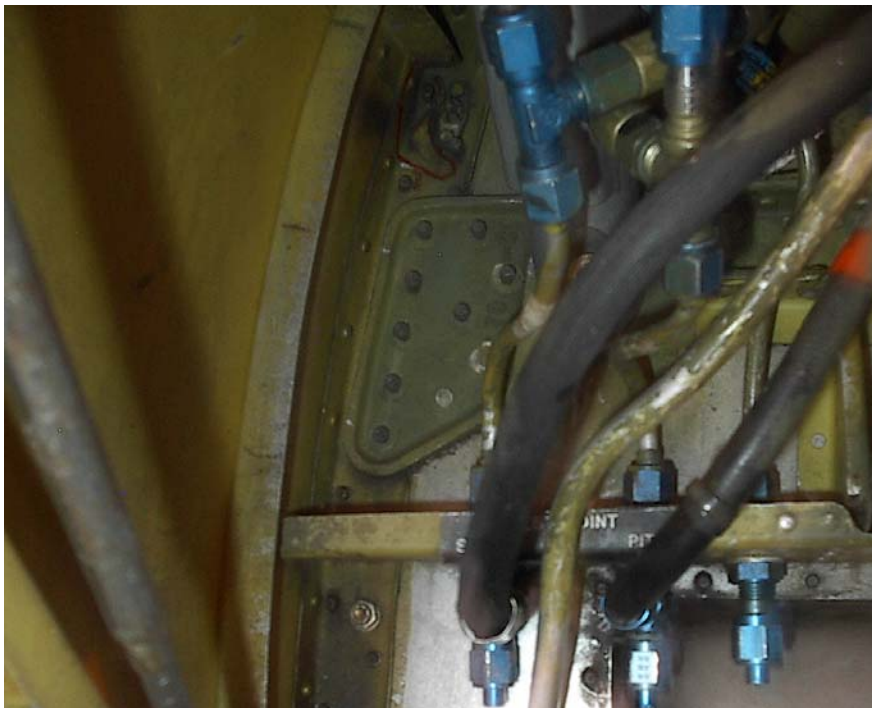
**5.4.1.8. Crack on LH Aft side of firewall directly opposite of engine cowl support bracket.**

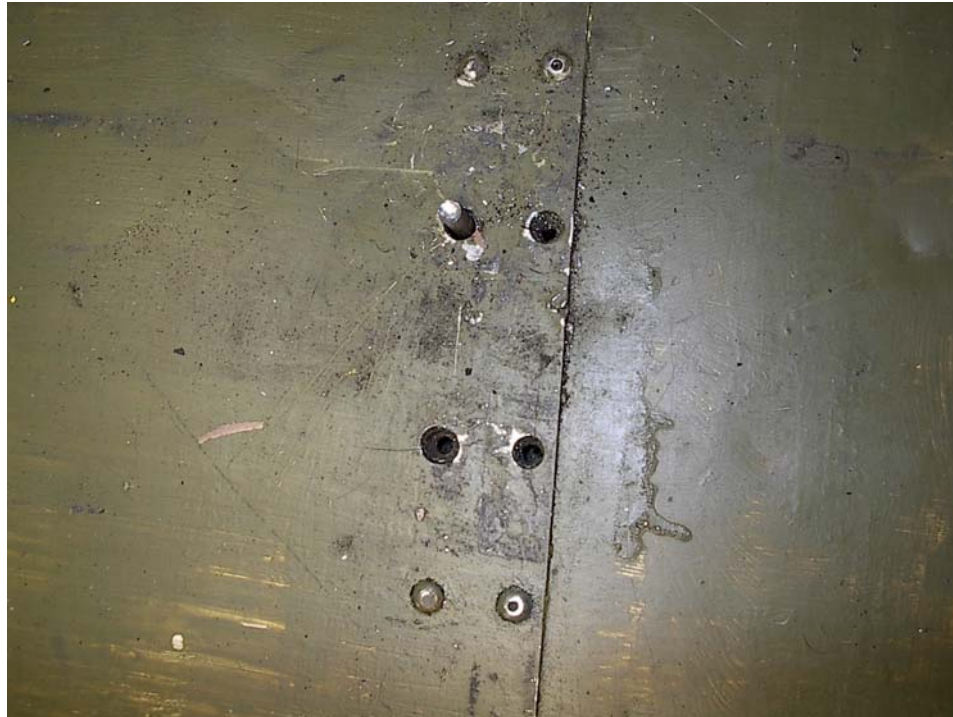
- 5.4.1.9. **Pilots rudder pedal assemblies worn at connecting rod attachment (no picture)**
- 5.4.1.10. **Loose/worn bolt in pilot's rudder pedal assembly (no picture)**
- 5.4.1.11. **Rudder torque tube attach bolts do not have castlating nuts installed (no picture)**
- 5.4.1.12. **Damaged screw in loose captivated nut in rear fuel bay at sub floor #4 RH AFT corner.**

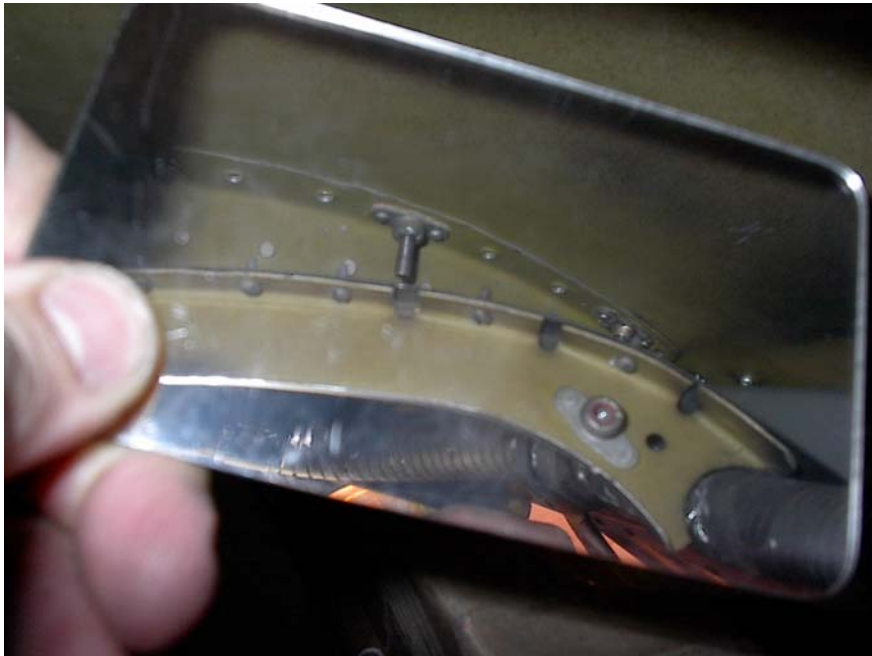
**5.4.1.16. 6 missing rivets, Co-pilot side behind radio panel, under co-pilot window retaining strip.**

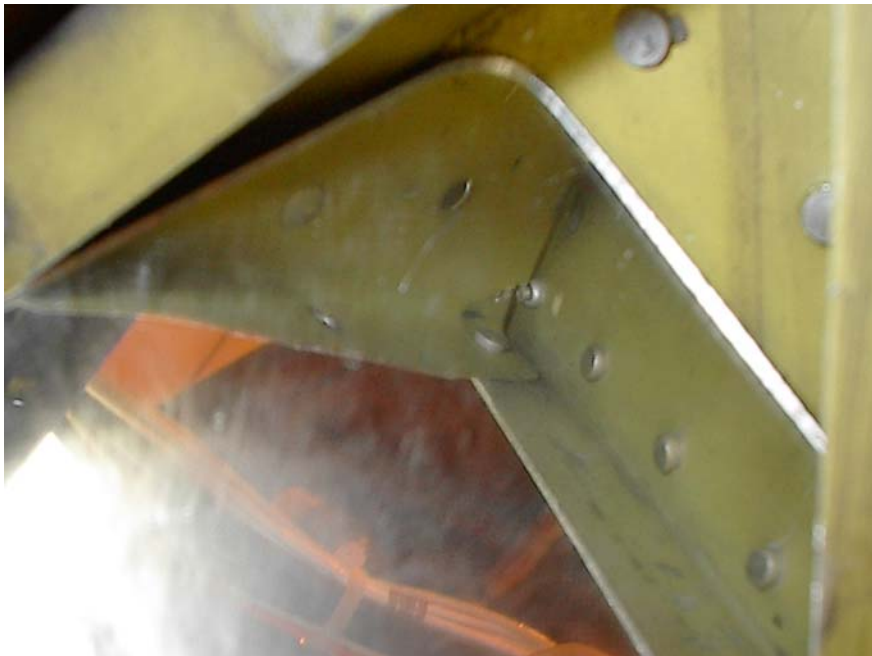
**5.4.1.17. Co-pilot R/H kick panel cross member angle cracked where it mates to entry door former.**

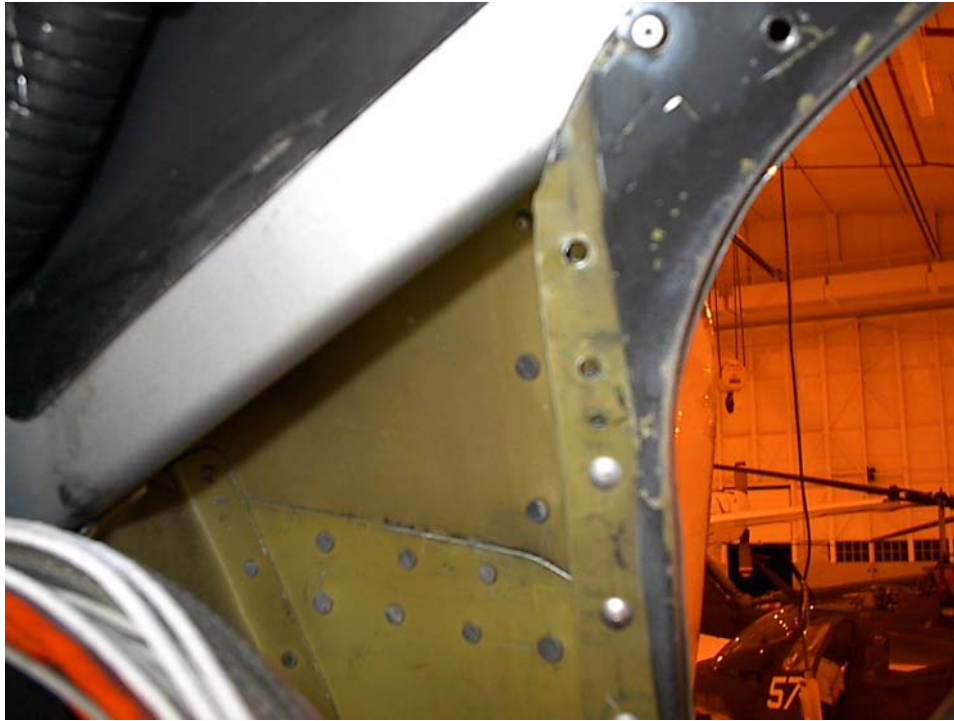
**5.4.1.18. 2 missing rivets near co-pilot hand hold assy.**

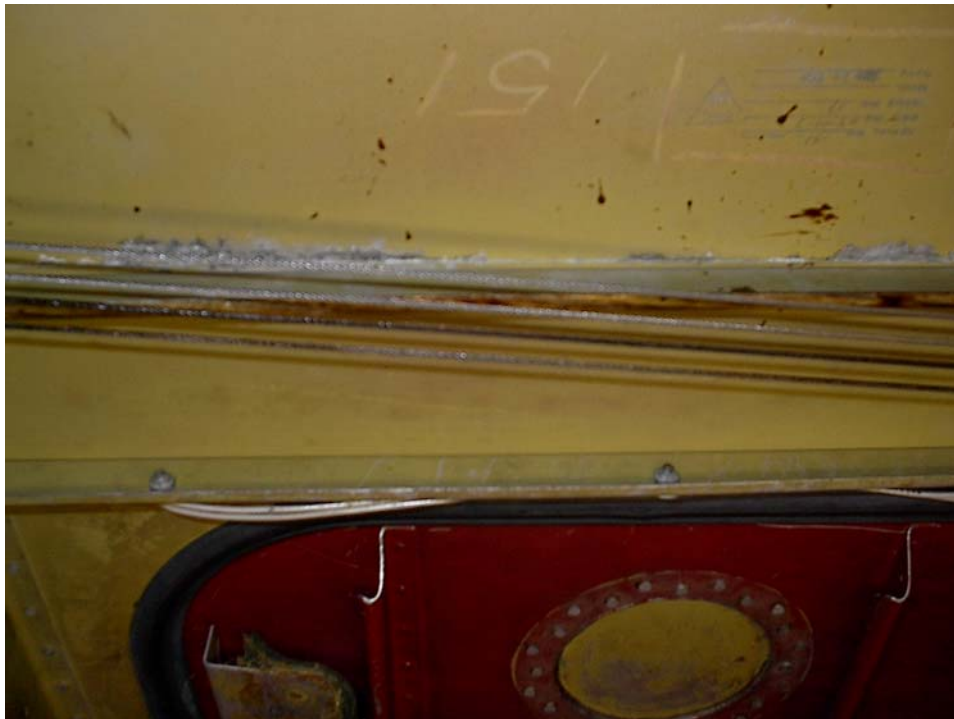
**5.4.1.19. Corrosion starting in ceiling stringer just aft of STN. 171.8 L/H side.**

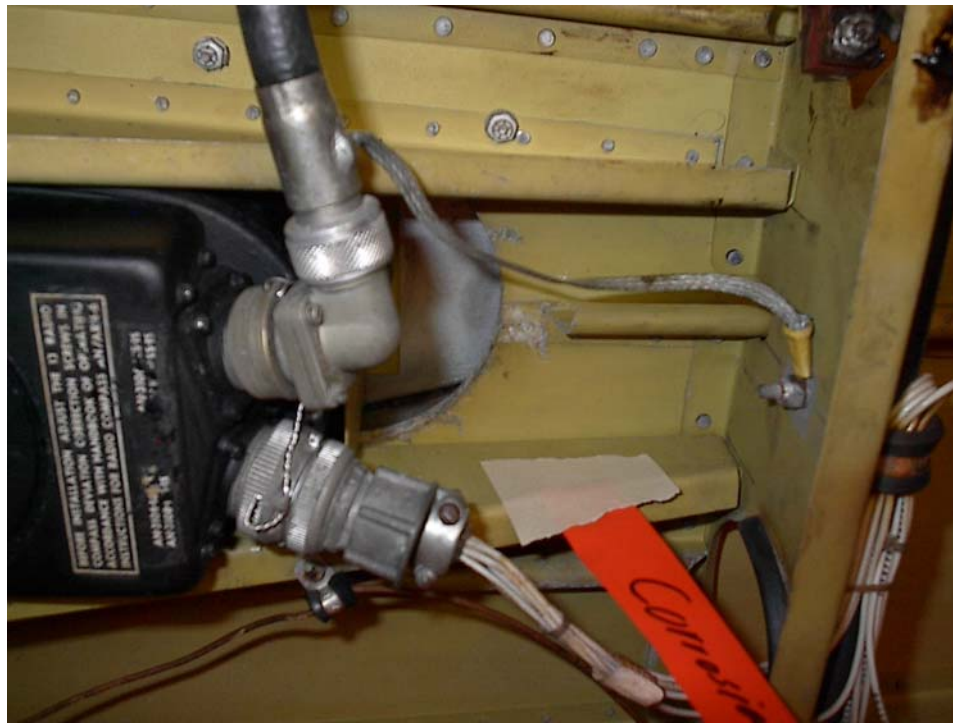
- 5.4.1.20. Corrosion starting in fuselage skin near roof mounted Ant. STN 204-220. Check seals around Ant. and treat corrosion.

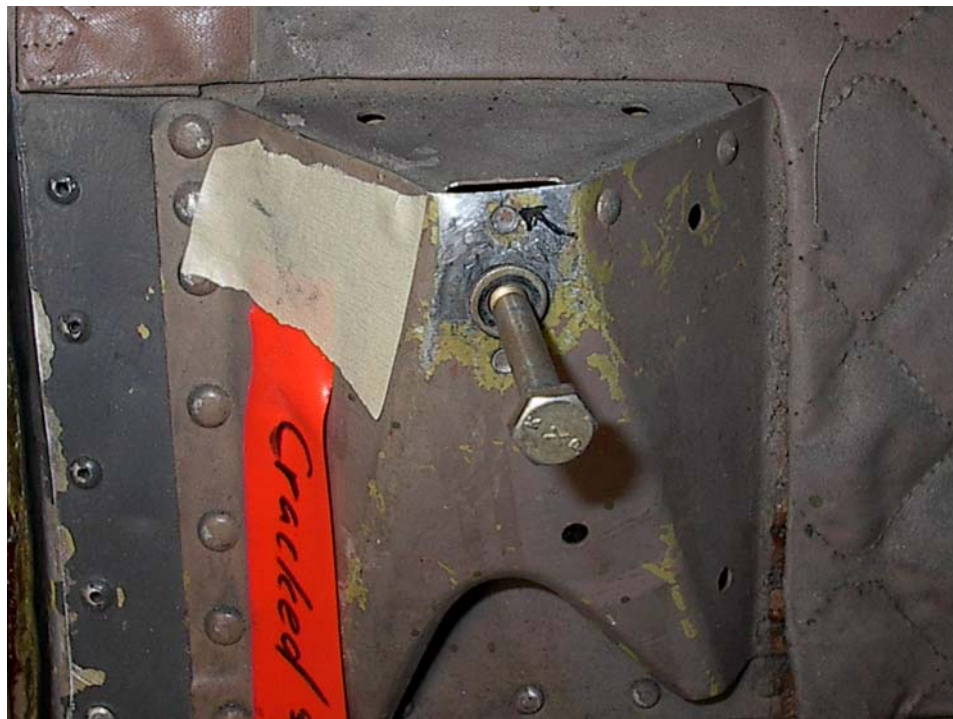
- 5.4.1.21. R/H rear jump seat lower attach point bracket is cracked.

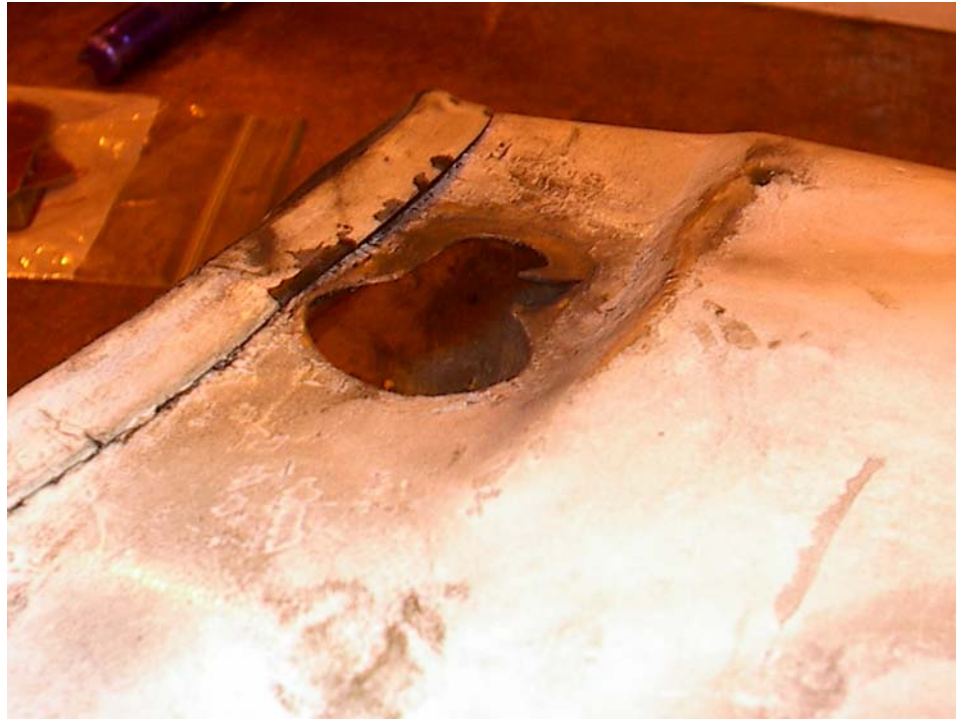
**5.4.1.22. Sheet metal crack in L/H LNG shock strut cuff upper fairing.**

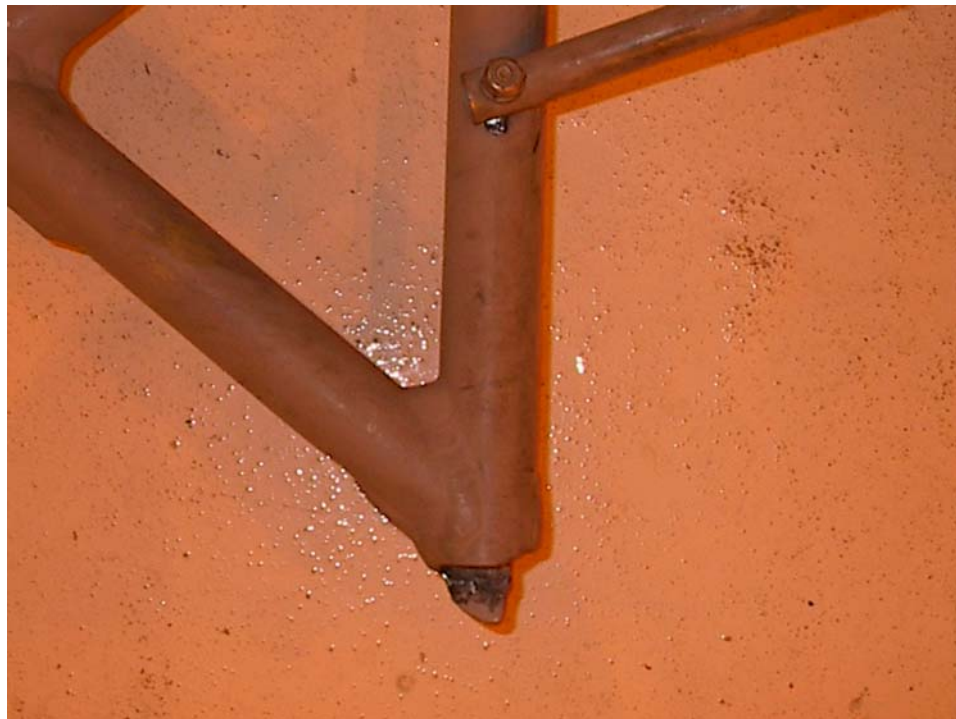
**5.4.1.23. R/H and L/H jump seat floor attach point "tang" is broken. I.P.C. pg. 244 Item-25**

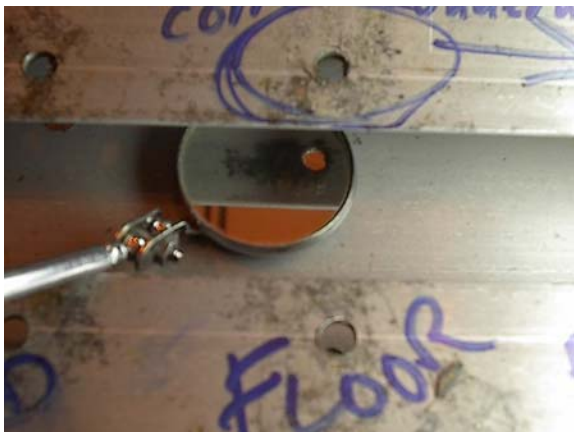
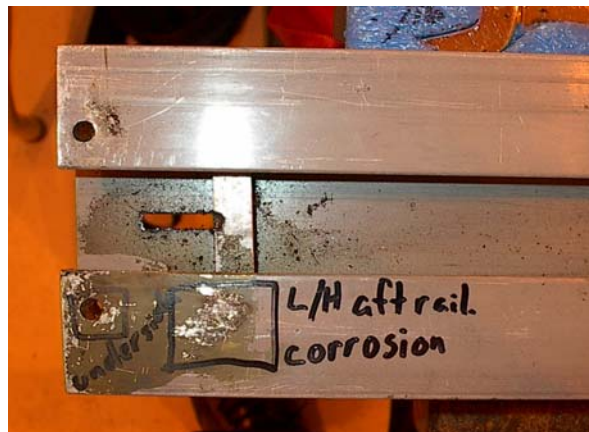
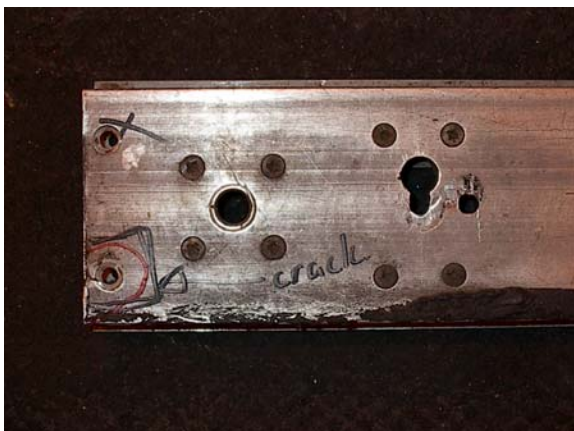
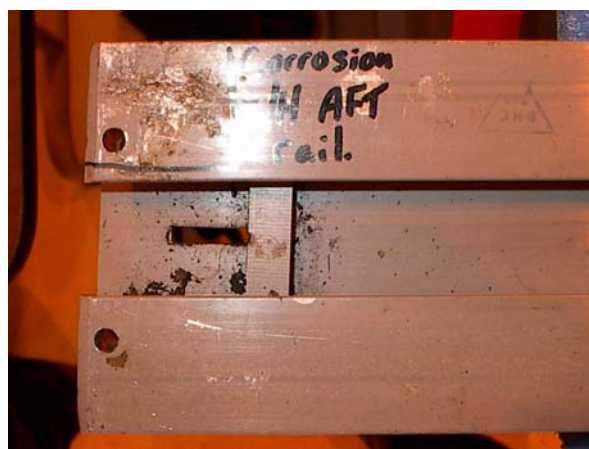
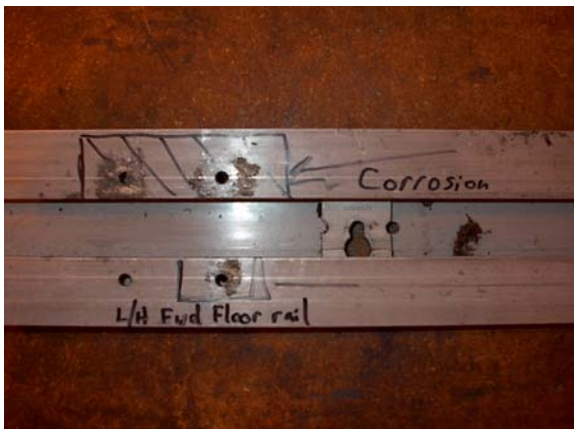
5.4.1.24. Floor rails have multiple corrosion spots and 1 crack as marked.

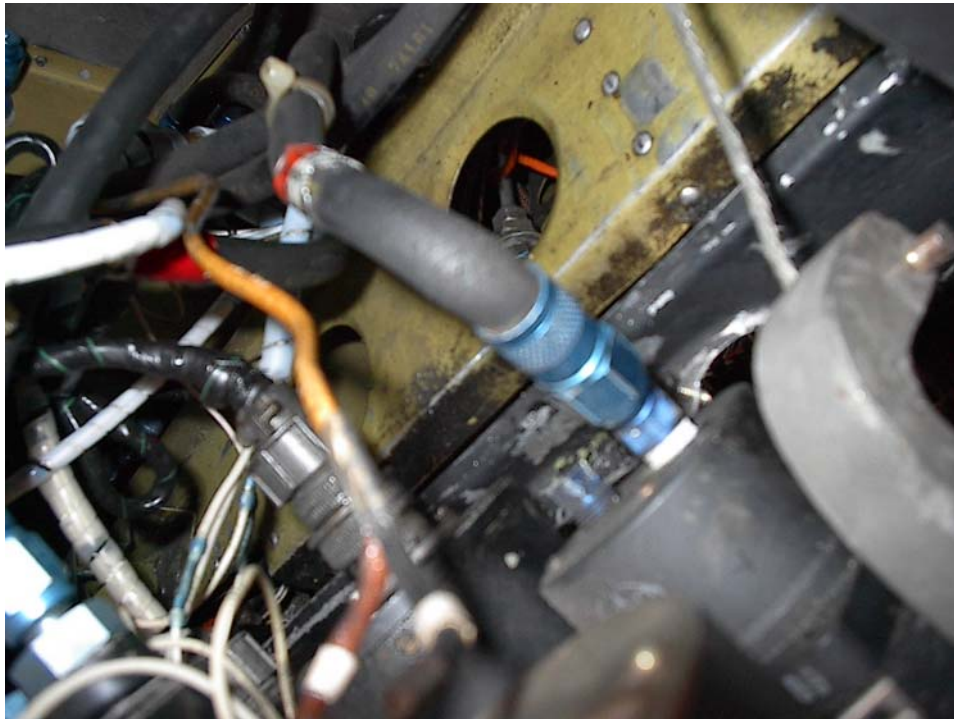
**5.4.1.25. Cockpit 3 --- Instrument vacuum hoses cracked and deteriorating.**

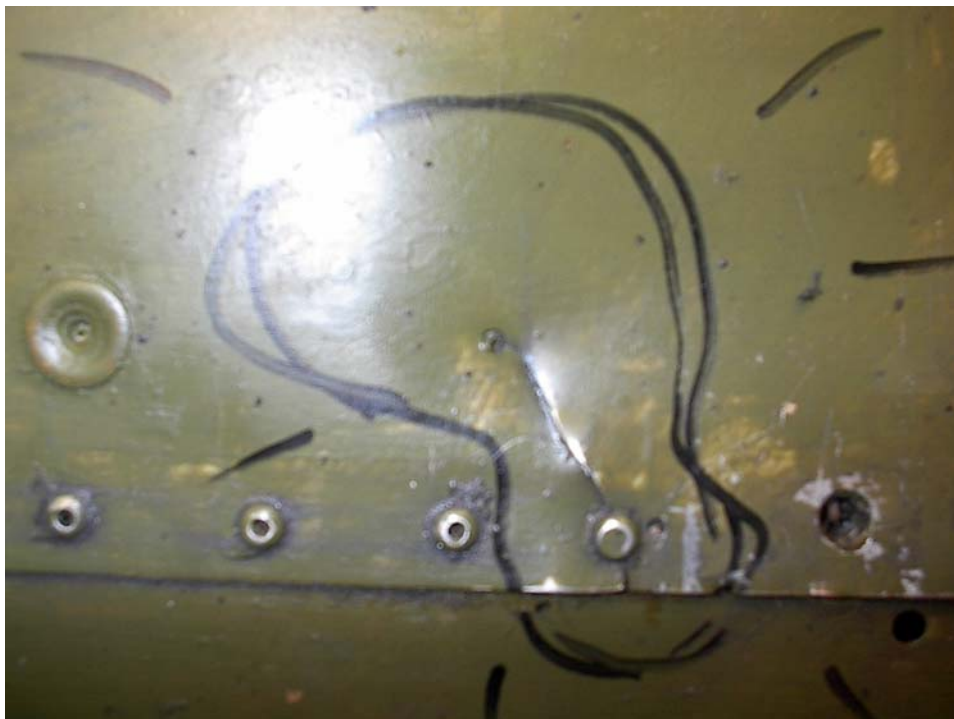
**5.4.1.26. Cabin sub floor #1 has a 1 ½ crack at the AFT bulkhead attach.**

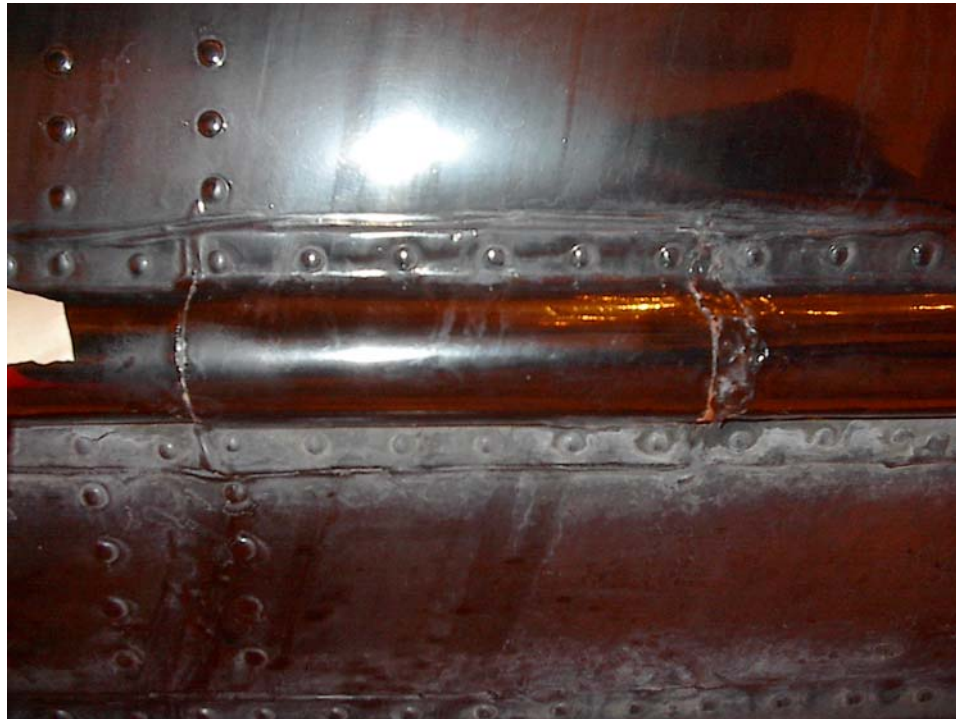
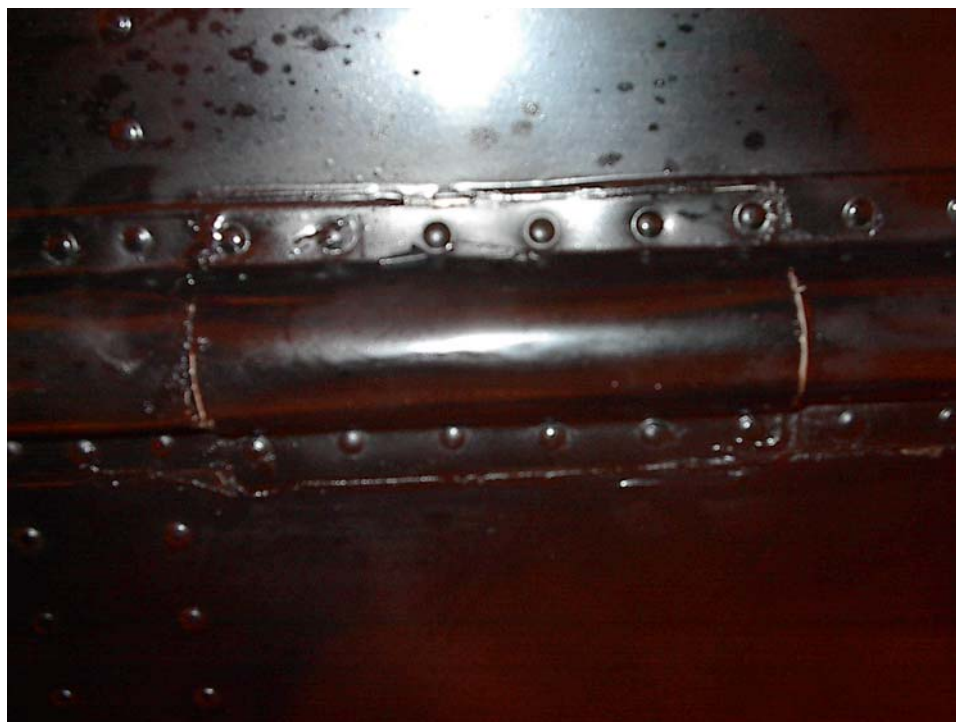
**5.4.1.29. 2 unapproved splices to hat section strips Fwd fuse bottom R/H side.  
Not I.A.W. SRM Fig 4-13 pg.67**

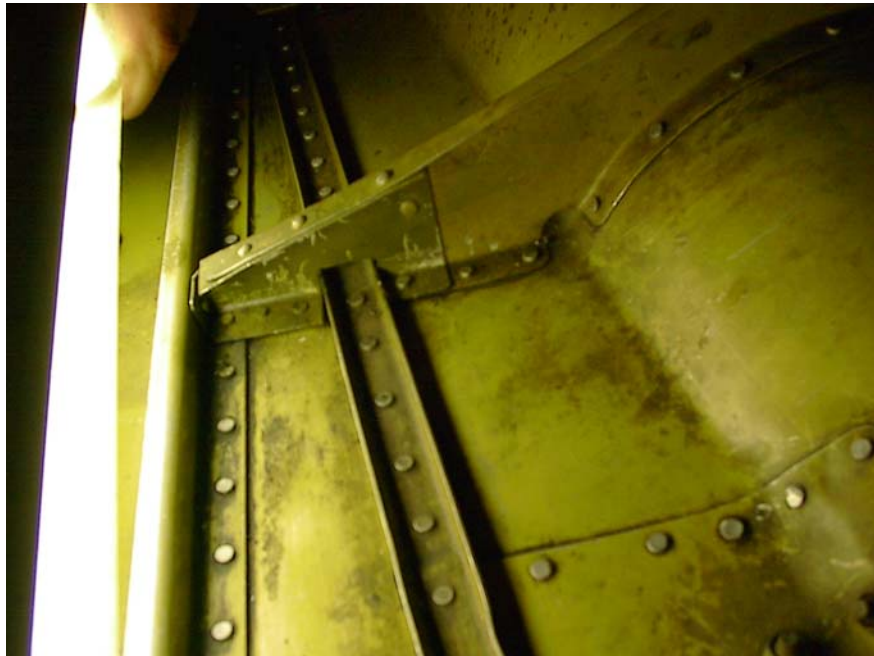
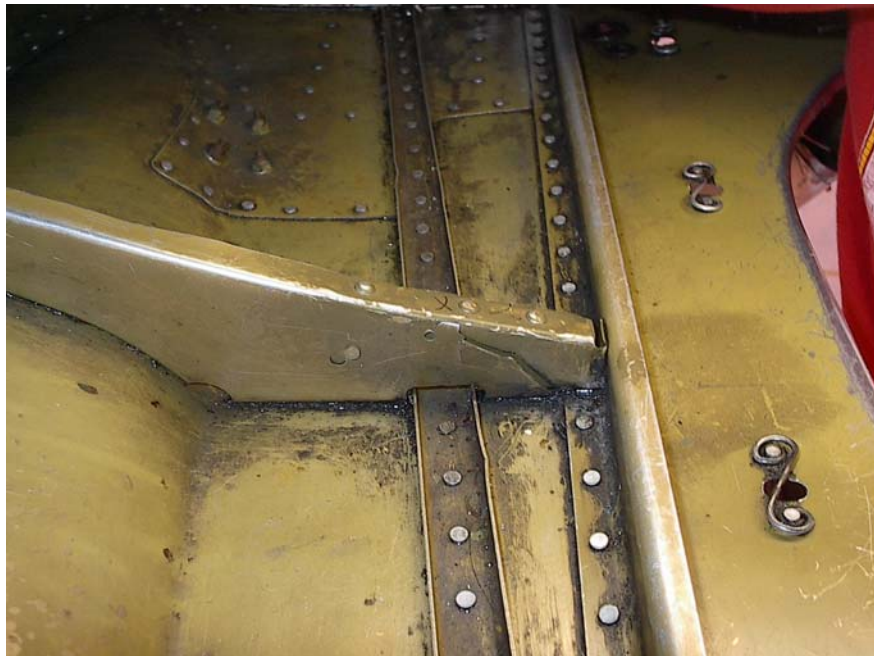
**5.4.1.30. 1 unapproved repairs to STA 93.0 Lower. R/H former. Not I.A.W. SRM  
Fig 4-9 pg. 63 DHC-3 S.R.M.**

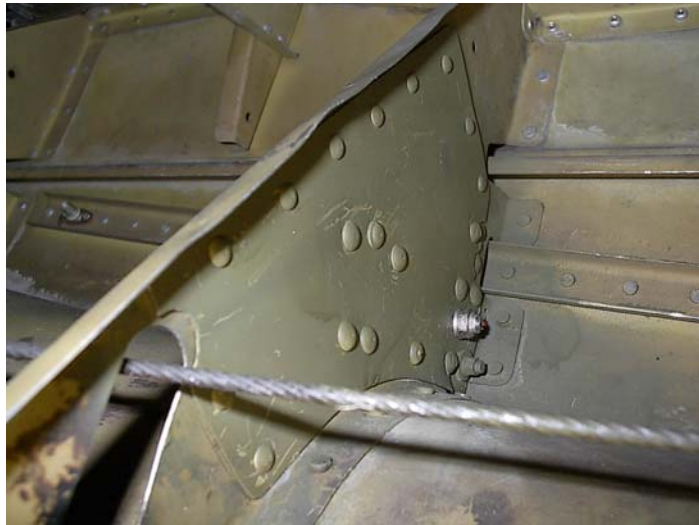
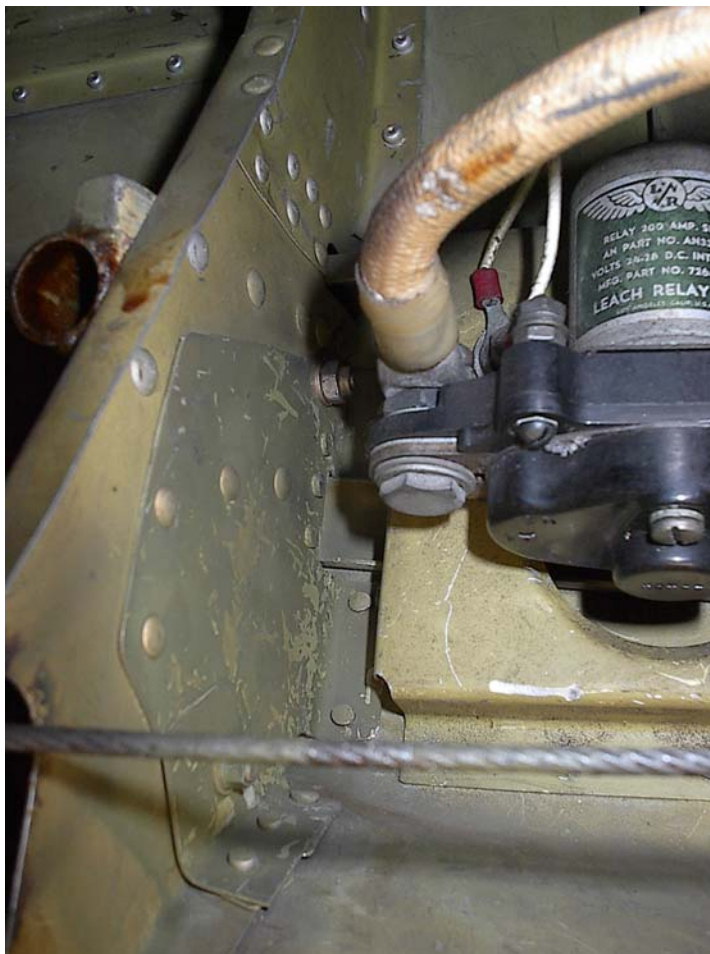
**5.4.1.31. 2 unapproved repairs to STA 83.25 Lwr R/H former not I.A.W. SRM Fig. 4-9 pg.63 SRM.**

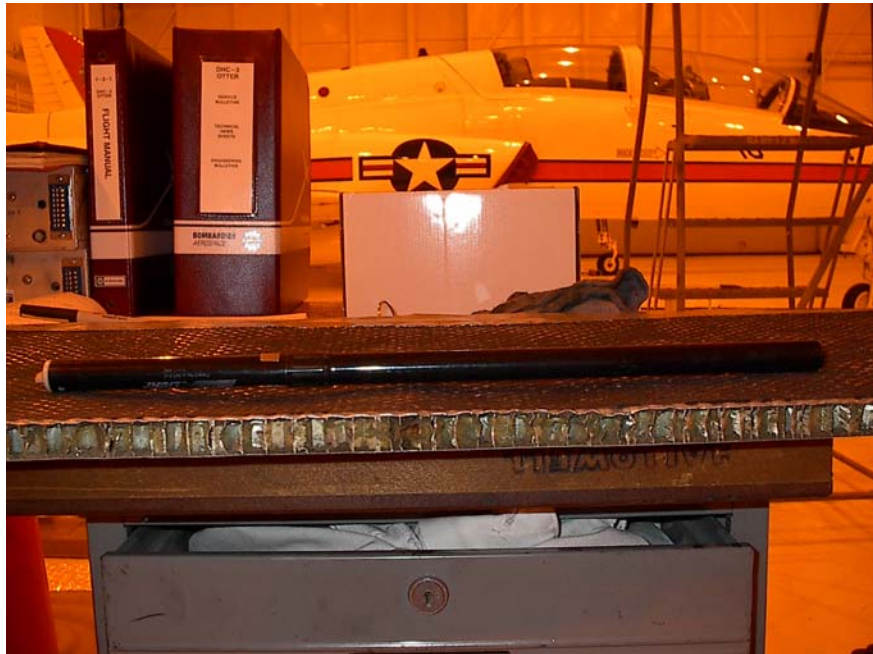
**5.4.1.33. Floor panel assy starboard rear part #C3FS310-11 badly deformed.**

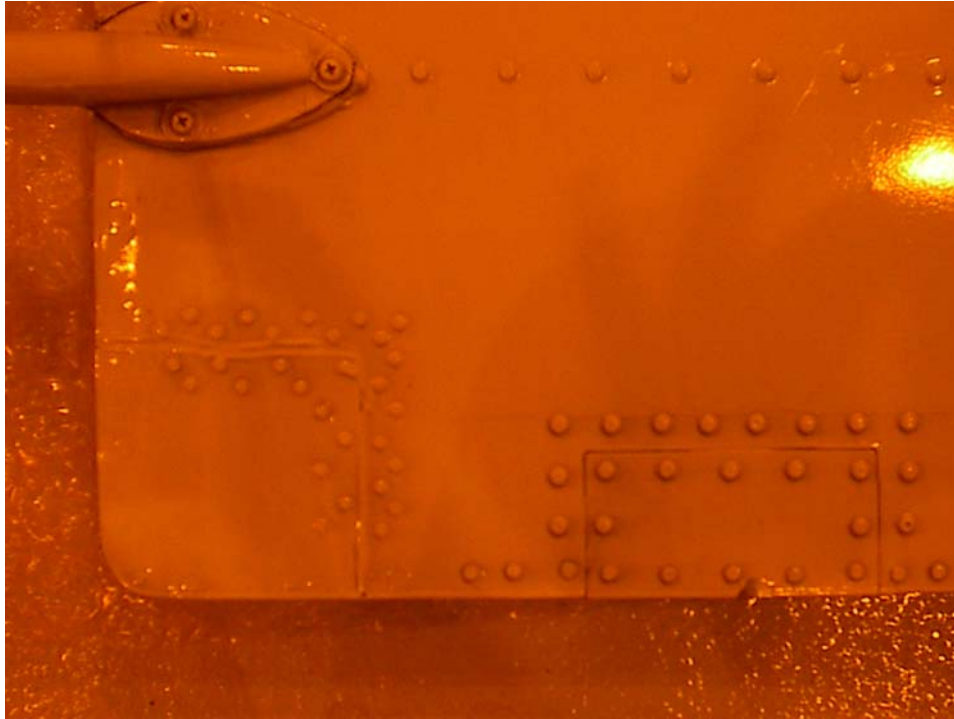
**5.4.1.35. LH forward cabin door has 2 non-standard sheet metal repairs.**

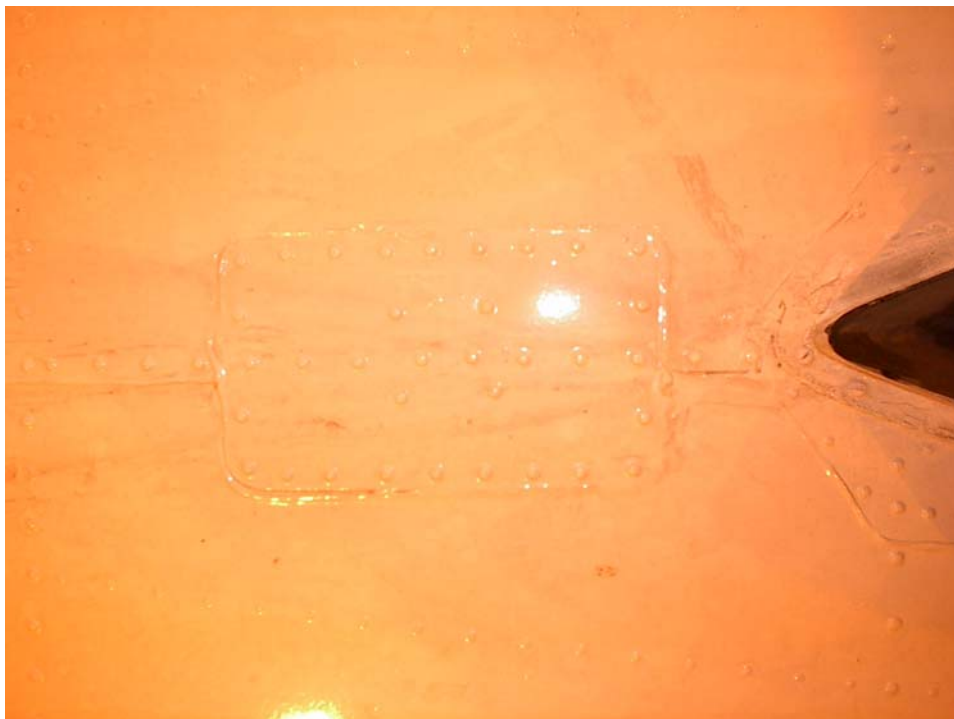
**5.4.1.36. Non-standard (unapproved) repairs to cabin roof top from station #224 to station #264.**

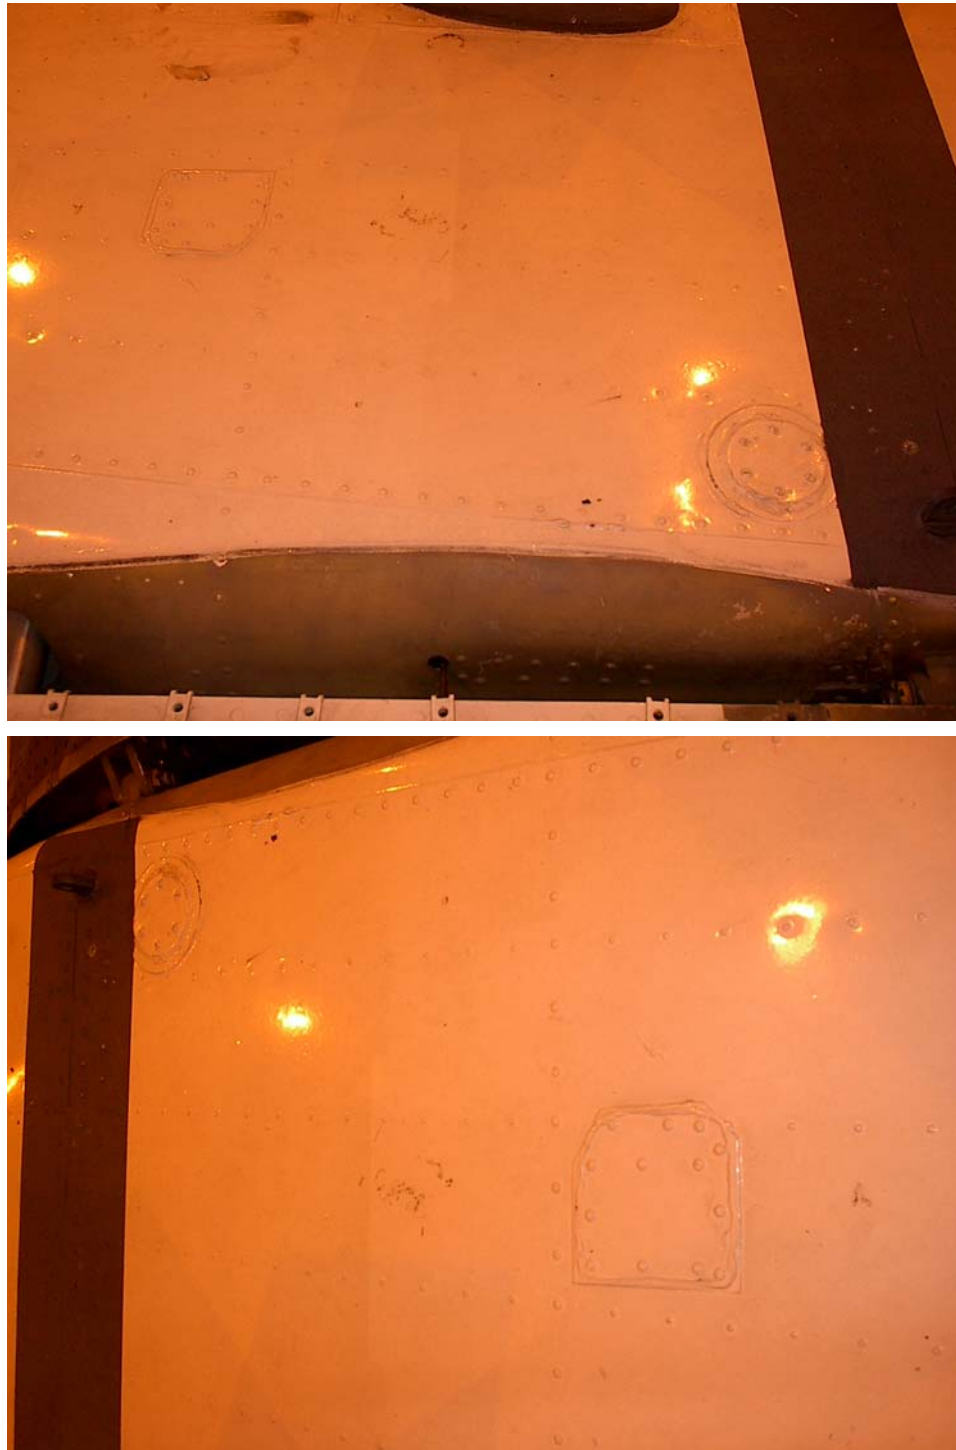
**5.4.1.37. (2) Non-standard (unapproved) repairs to cabin roof top from station 139 to station #162.**

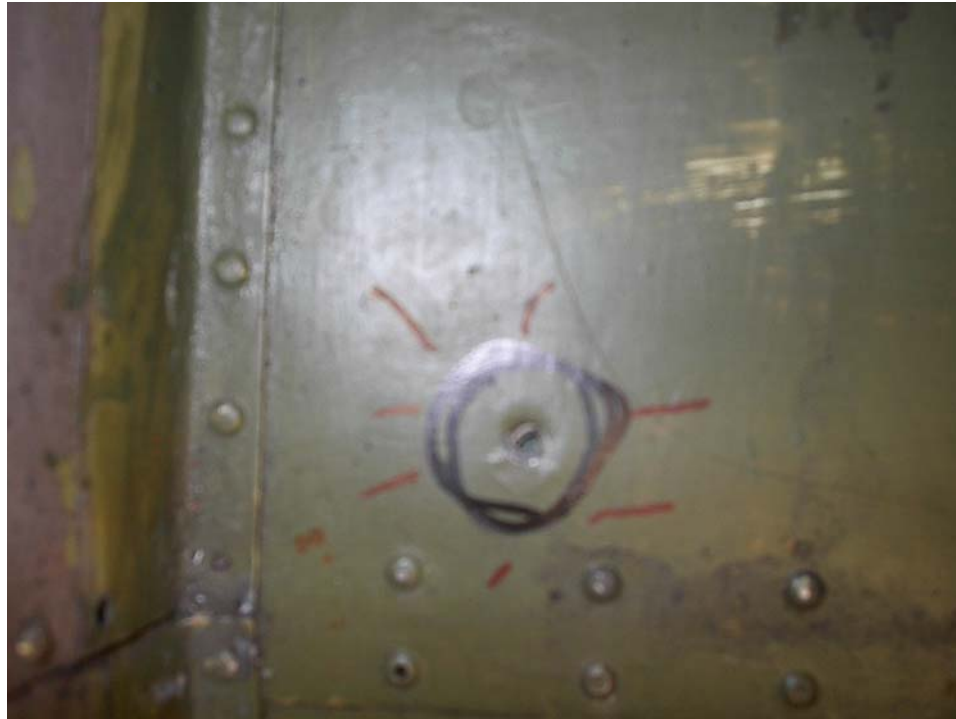
**5.4.1.38. Cabin sub floor #4 has 1 hole in AFT LH corner**
